The Ribbon of Green

Change in Riparian Vegetation in the Southwestern United States

Robert H. Webb, Stanley A. Leake, and Raymond M. Turner

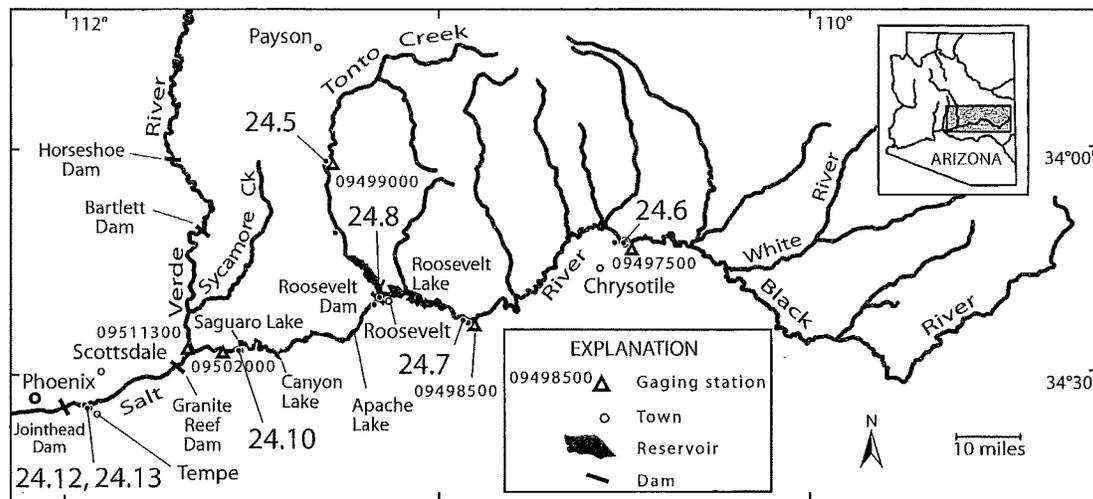
Figure 24.1 Map of the Salt River in central Arizona.

Arising along the Mogollon Rim in east-central Arizona, the Black and White Rivers merge to form the Salt River, which then flows 200 miles to its confluence with the Gila River (fig. 24.1). The Salt's drainage area of 13,223 square miles includes some of the most rugged mountainous and desert terrain in Arizona. Downstream from the Black-White River confluence, the river is confined in Salt River Canyon before emerging into shallow alluvial basins upstream from Theodore Roosevelt Lake. A series of four

square miles below the Mogollon Rim of central Arizona (fig. 24.1). As with many drainages in this region, floods can be extremely large during regional storms. The flood of record, which occurred during the January 1993 floods, had a peak discharge of 72,500 ft³/s (fig. 24.4). The effect of the early-twenty-first-century drought is shown in the substantial decrease in peak discharges between 1996 and 2002 in this drainage basin. Despite the floods and perhaps because of a sustained drought period, photographs show that riparian vegetation has increased

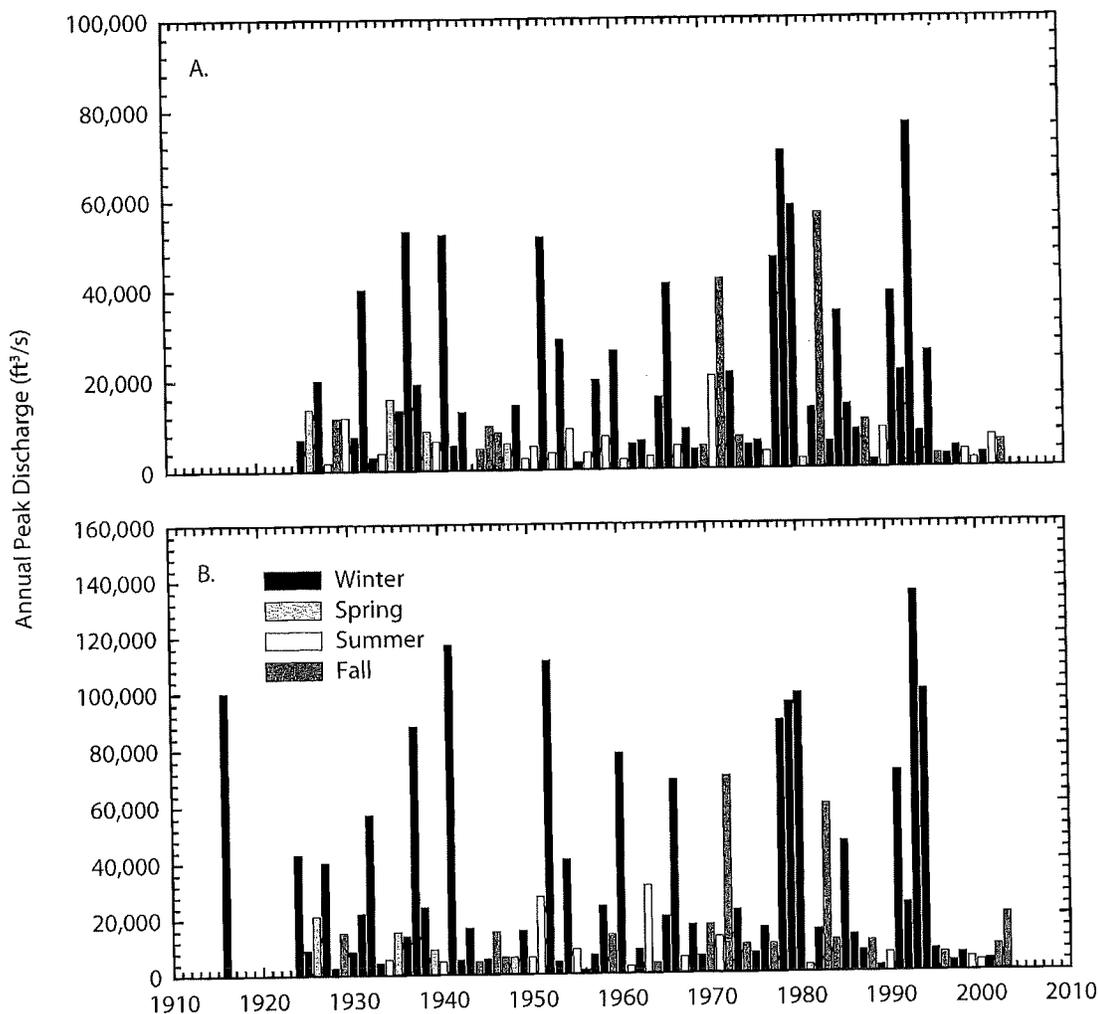
Figure 24.2 Annual flood series for the Salt River.

A. The Salt River near Chrysotile, Arizona (station 09497500; 1925–2003).

B. The Salt River near Roosevelt, Arizona (station 09498500; 1916, 1924–2003).

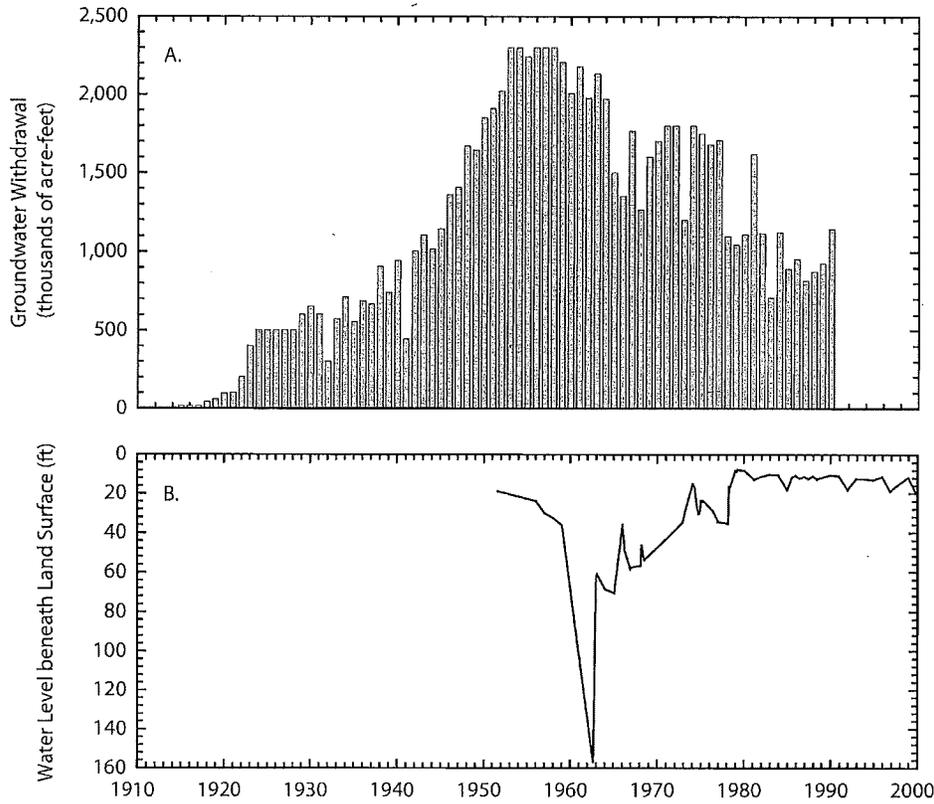
Figure 24.3 Groundwater records for the Salt River Valley near Phoenix.
 A. Annual amount of groundwater used in Maricopa County (from Anning and Duet 1994).
 B. Groundwater levels for well B-01-02 36BBC near the Salt River in Phoenix, Arizona.

accelerate in the 1920s following the development of turbine pumps (fig. 24.3).²² As water levels dropped, some fragile layers in the alluvial aquifer drained and compacted, causing subsidence of the ground surface. In the Salt River Valley, problems attributed to land subsidence, including earth fissures and collapsed well casings, were documented by the early 1960s.²³ Excessive groundwater development in the Salt River Valley led to the creation of the Phoenix Active Management Area in 1980.²⁴ Water levels in some areas had declined as much as 450

feet between 1923 and 1982. Nearer to the Salt River, water levels that had declined in the 1960s rebounded by the 1980s (fig. 24.3B), responding to the combination of flood releases and use of CAP water imported from the Colorado River.

Following heavy usage in the middle of the twentieth century, groundwater levels rebounded and remained high near the Salt River (fig. 24.3B). The declines were in part in response to the midcentury drought, and the rebound occurred at least in part because of importation of CAP water to the Phoenix basin in 1985.³⁰ In the latter half of the twentieth century, the Salt River alternated between extreme floods and drought (fig. 24.11), hardly conditions that would sustain growth of significant amounts of riparian vegetation. However, a time series of aerial photographs³¹ shows the midcentury establishment and destruction of considerable riparian vegetation—possibly dominated by tamarisk—along the Salt River upstream from the Mill Avenue Bridge in Tempe. The destruction was largely complete at the time of a devastating flood in late December 1965.

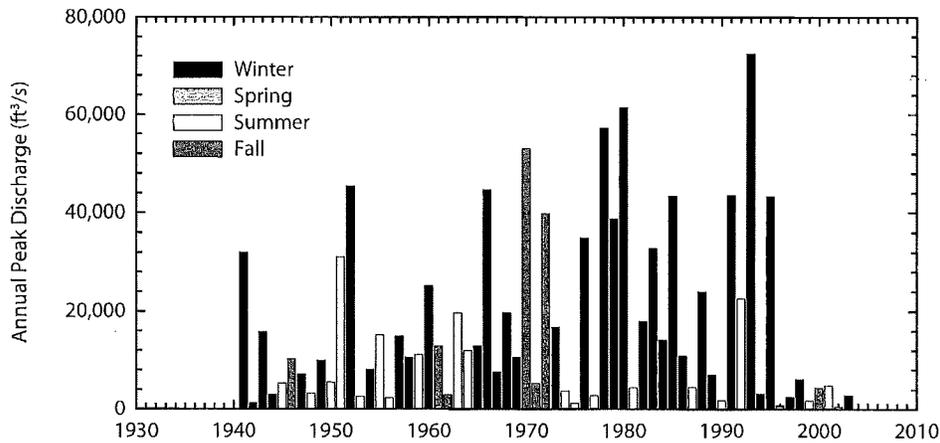
Figure 24.4 Annual flood series for Tonto Creek above Gun Creek, near Roosevelt, Arizona (station 09499000; 1941–2003).

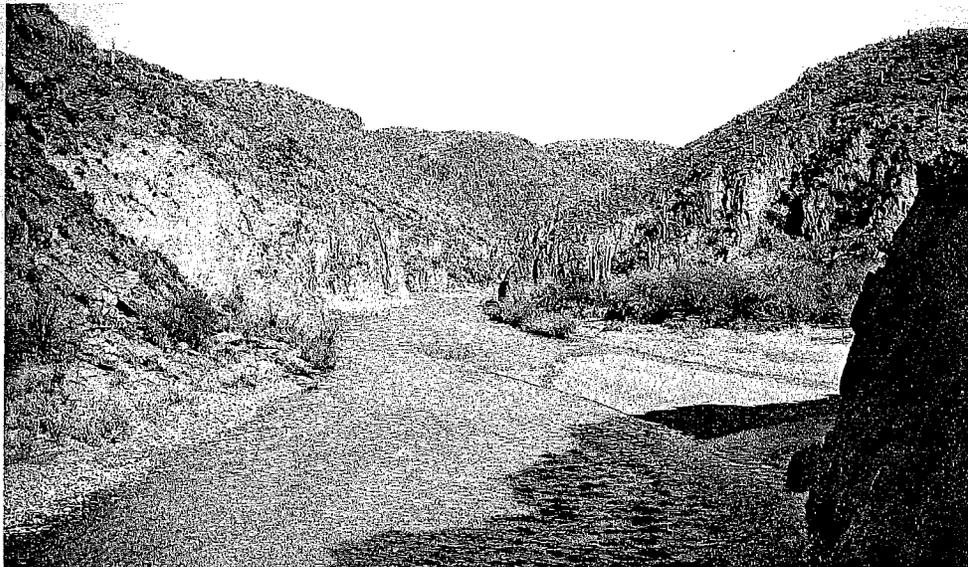
A

Figure 24.5 Photographs of Tonto Creek.

A. (February 1, 1941.) This upstream view of Tonto Creek shows the approach to the gaging station within a bedrock canyon with a flow of 456 ft³/s. Riparian vegetation covers the few alluvial terraces, notably the one on river left (*photo right*). The vegetation appears to be mostly mesquite with scattered willows. (J. A. Baumgartner 3403, courtesy of the U.S. Geological Survey.)

along Tonto Creek, even in relatively narrow channel reaches (fig. 24.5). Other photographs near the delta with Theodore Roosevelt Lake show similar increases, although tamarisk is more abundant.

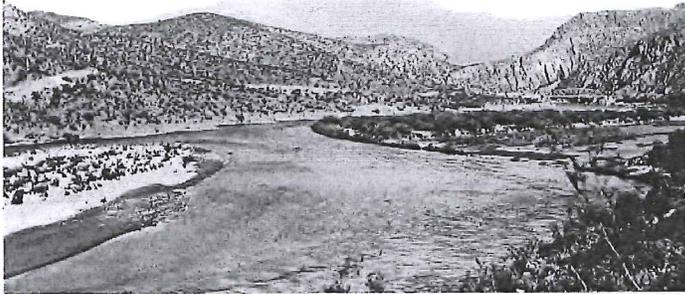
A. (April 22, 1937.) In this upstream view, the Salt River is flowing at 4,000 ft³/s. The long-term gaging station in this reach is associated with the bridge in the distance, and a diversion dam is present just downstream from the camera station. Two months before this photograph was taken, the brush-covered island at right center was submerged during a February flood; most floods on the Salt River occur during the winter months. This camera station is several miles upstream from the top of Roosevelt Lake, the first of the major flood-control and water-supply structures on the Salt River upstream from Phoenix. (W. E. Dickinson 2166, courtesy of the U.S. Geological Survey.)

Figure 24.7 Photographs of the Salt River near Roosevelt, Arizona.

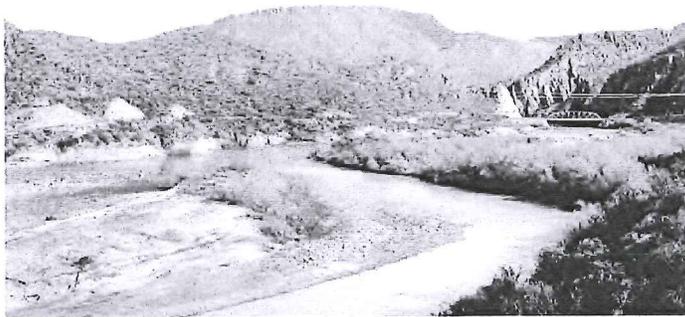
B. (February 3, 1979.) The brush-covered island is now densely covered with mostly nonnative tamarisk, although many native species also occur in this reach, including cottonwood, coyote willow, black willow, and various species of brickellbush. The bar in the left foreground was scoured during large floods in both 1978 and 1979. (R. M. Turner.)

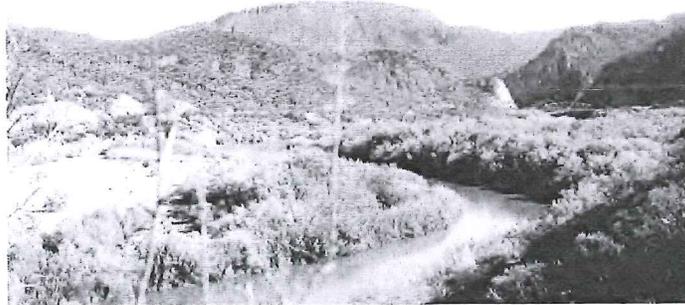
C. (November 25, 2000.) Flood frequency on the Salt River did not change significantly in the twentieth century, as it did on other rivers in the region, although four one-hundred-year floods did occur in a fifteen-year period. The 1993 flood, which had a peak discharge of 143,000 ft³/s at the gaging station on the bridge visible in the distance, did little to slow the advance of riparian vegetation—in particular tamarisk—at this site. Native species, notably carrizo grass, have also increased, although they are difficult to distinguish from the tamarisk in this view. (D. Oldershaw, Stake 955.)

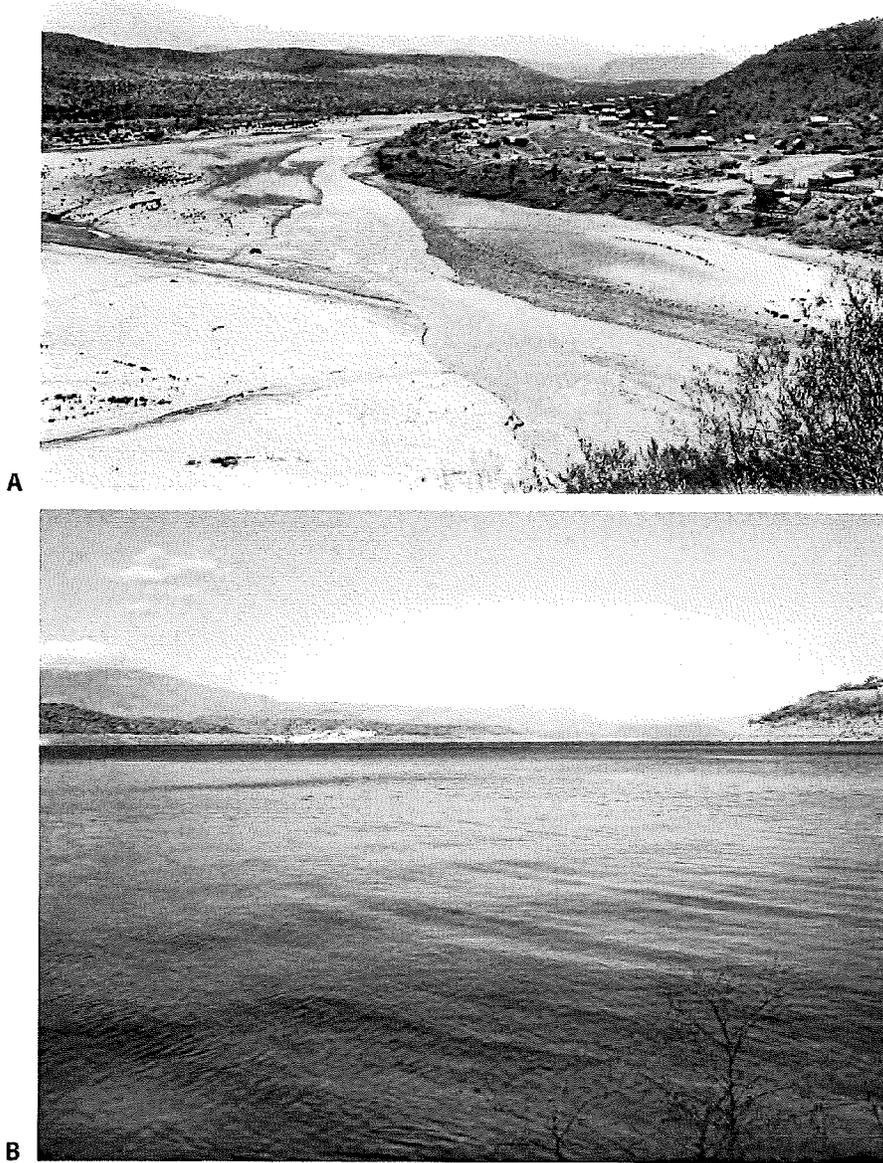
Figure 24.8 Photographs of the Salt River at Roosevelt, Arizona.

A. (Ca. 1910.) This view and several others taken immediately before completion of Roosevelt Dam show the crossing of the Salt River at the town of Roosevelt. Tonto Creek enters the Salt River from the left. The channel is wide and mostly barren of riparian vegetation, although discontinuous patches of what likely is mesquite appear on the floodplain in the midground. (G. W. James P4539, courtesy of the Southwest Museum.)

B. (April 8, 2004.) Theodore Roosevelt Lake now covers the former town of Roosevelt, which was moved several miles toward Globe, Arizona, after construction of Roosevelt Dam was completed. As this view shows, lake level fluctuates, minimizing establishment of riparian vegetation on coarse talus slopes. (D. Oldershaw, Stake 4770.)

it covers about 10 miles of the once free-flowing Salt River and 8 miles of Tonto Creek in a relatively wide reach. All woody riparian vegetation in these reaches was killed, but replacements occurred on the delta. As shown in figure 24.8, little riparian vegetation was present in 1910 at the confluence of the Salt River and Tonto Creek, just upstream from the present-day location of the dam. Fluctuations in lake level preclude establishment of significant riparian vegetation along the steep shoreline (fig. 24.8B), although tributary deltas can support dense stands of mostly nonnative vegetation.

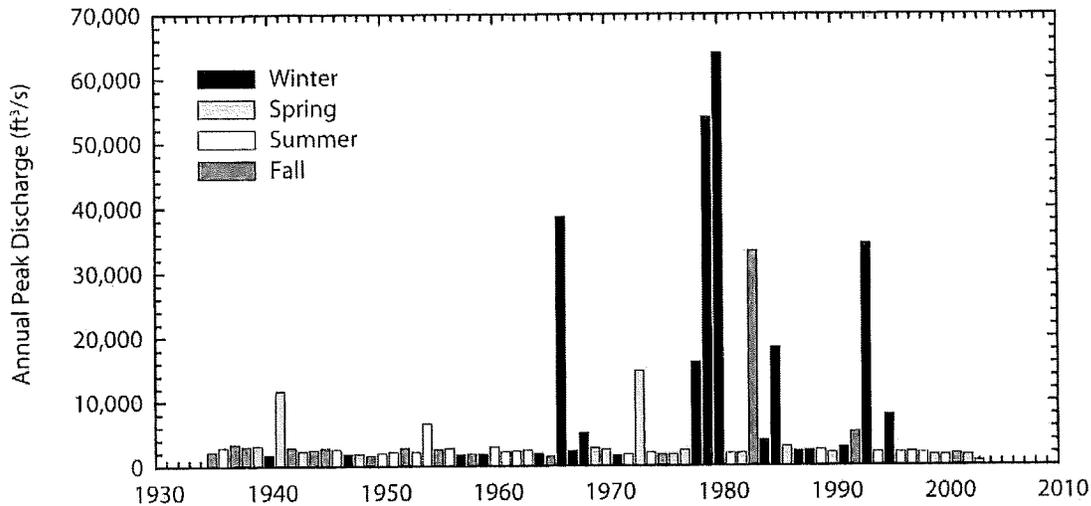
Figure 24.9 Annual flood series for the Salt River below Stewart Mountain Dam, Arizona (station 09502000; 1935–2003).

B. (March 7, 1979.) This view, taken after the 1978 and 1979 floods (highest peak discharge was $54,000 \text{ ft}^3/\text{s}$, fig. 24.9), shows a wide, scoured floodplain with a low flow of $13 \text{ ft}^3/\text{s}$. Other photographs taken in this reach indicate that although the bars remain composed mainly of cobbles, the average particle size has coarsened, indicating further degradation of habitat within the low floodplains. Despite the floods, tamarisk remains on river right. (R. M. Turner.)

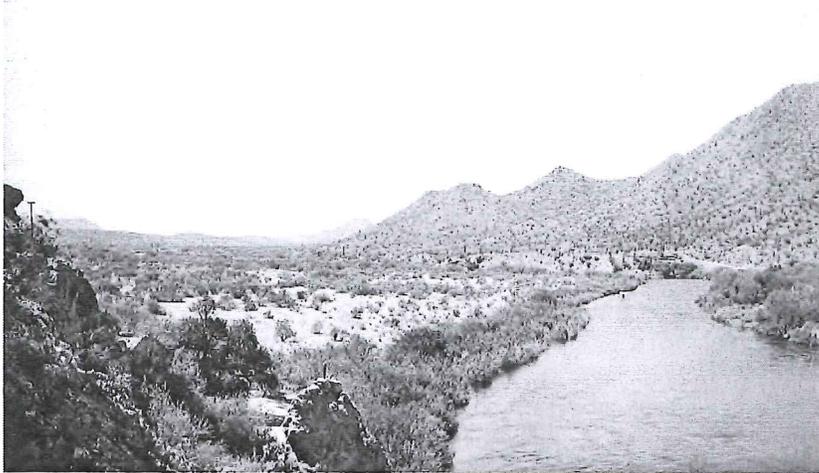
A. (September 9, 1938.) This downstream view of the Salt River below Stewart Mountain Dam shows low, woody riparian vegetation encroaching to water level on both banks. Flow at the time of this photograph is $2,390 \text{ ft}^3/\text{s}$ and is completely regulated by the four dams upstream. The vegetation consists of seepwillow and brickellbush, with scattered tamarisk trees on river right. (J. A. Baumgartner 2391, courtesy of the U.S. Geological Survey.)

Figure 24.10 Photographs of the Salt River below Stewart Mountain Dam.

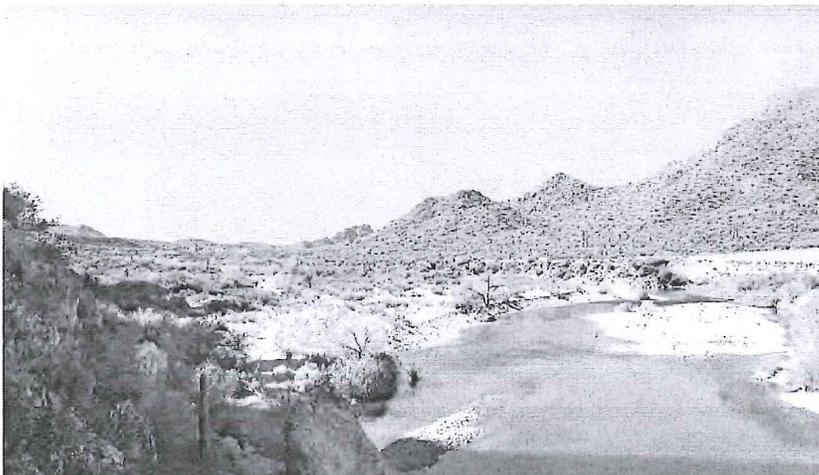
C. (January 31, 1995.) This view, taken after the 1993 peak discharge of $34,500 \text{ ft}^3/\text{s}$, shows an even coarser particle size on the floodplain. The flow is $470 \text{ ft}^3/\text{s}$. The channel position has shifted in response to rearrangement of the coarse sediment within the channel. One tree that survived the floods of the late 1970s and early 1980s is dead in the center of the view. Low shrubs, tamarisk, and cottonwood appear to be established. (D. Oldershaw, Stake 962.)

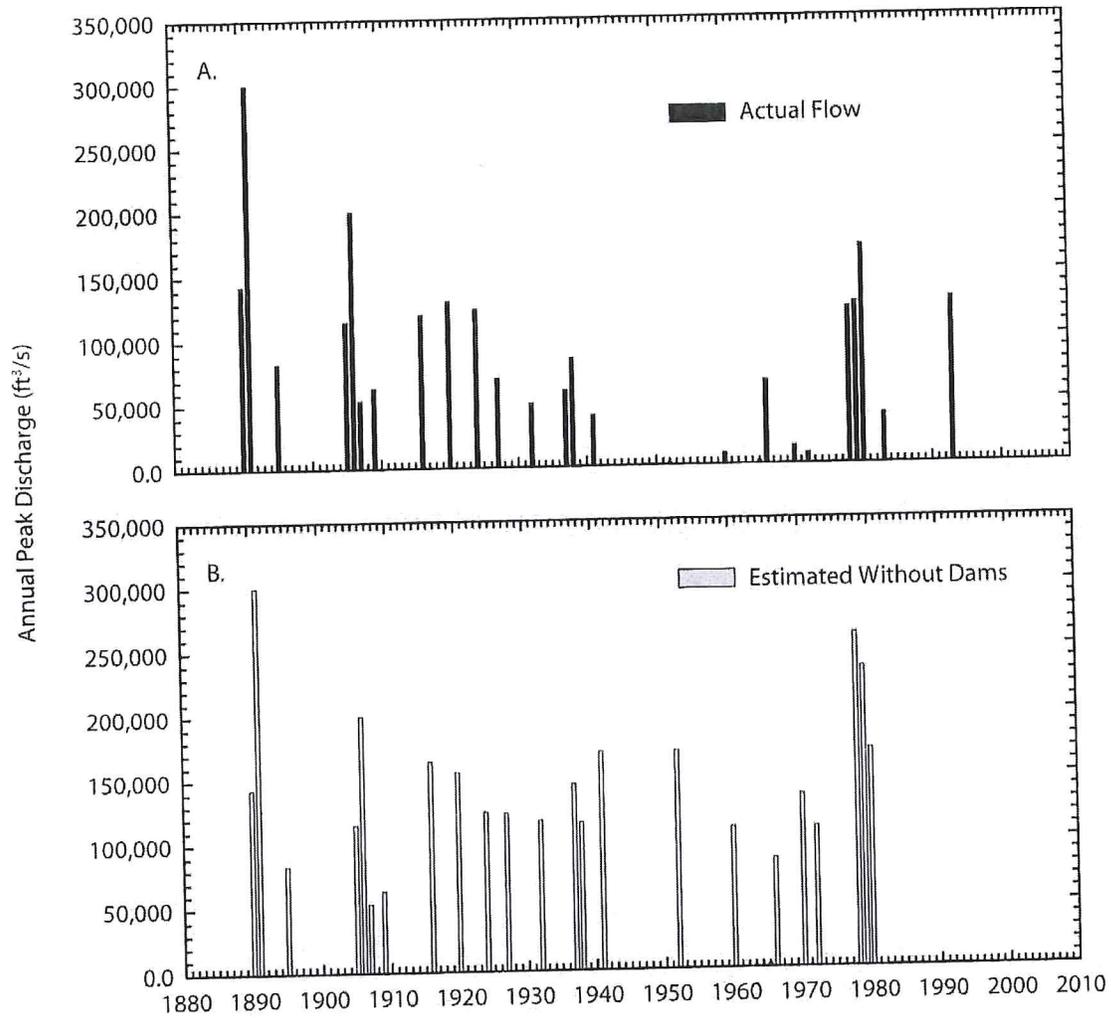
Figure 24.11

A. Annual flood series for the Salt River at Jointhead Dam near Phoenix, Arizona (station 09512060; various years). During many years, the Salt River does not flow here.

B. Annual flood series that would have occurred if the upstream dams were not in place (from Aldridge and Eychaner 1984). The data in series B represent only 1890–1980; clearly, floods would have occurred in other years if dams had not been completed upstream.

14. Durrenberger and Ingram (1978).
15. Aldridge and Eychaner (1984). The reported discharge is for Salt River at Alma School Road near Mesa, Arizona (09512060); see figure 24.11.

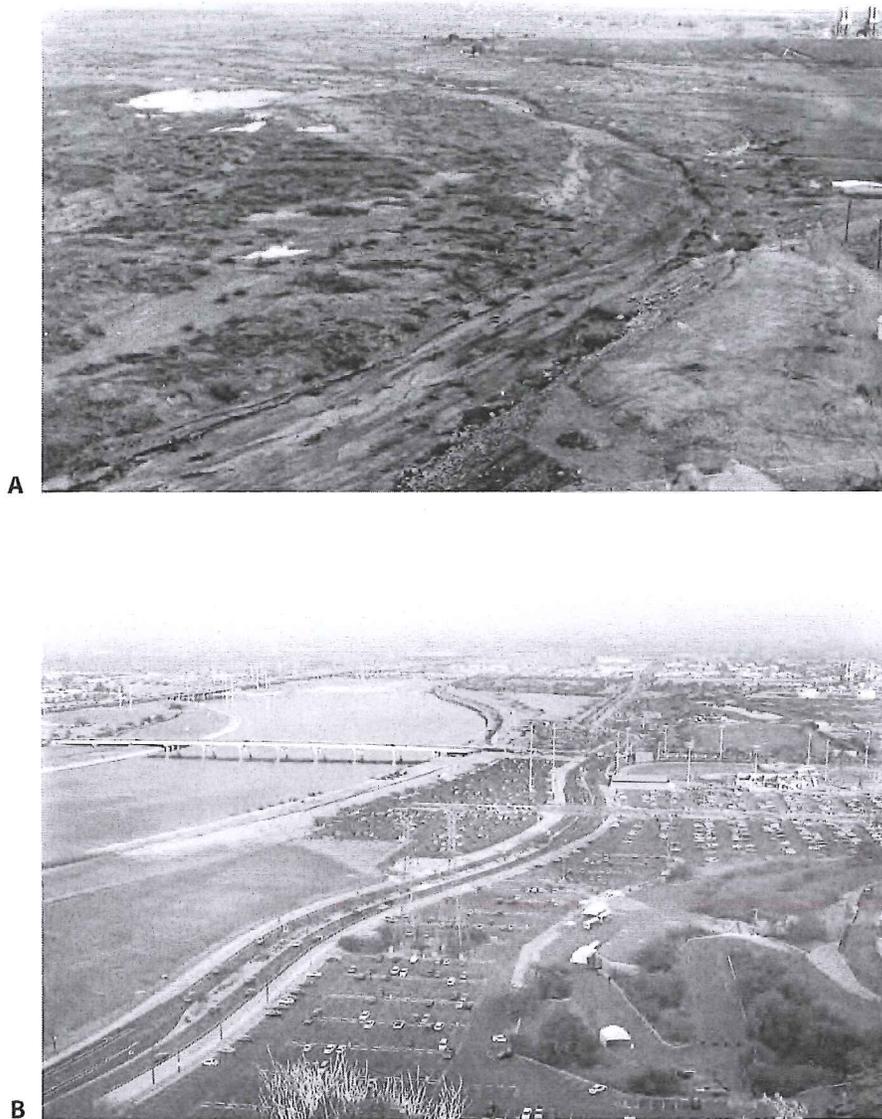
Figure 24.12 Upstream photographs of the Salt River in Tempe, Arizona.

A. (Just after December 11, 1959.) This upstream view from Tempe Butte shows the Salt River through Tempe after a relatively minor flood of less than 200 ft³/s released from dams on the Salt and Verde Rivers on December 11. The dike across the right midground likely provided minimal flood protection for part of Tempe. Older photographs of this reach suggest that the combination of high groundwater conditions and the wide channel allowed sparse, mainly nonwoody riparian vegetation to exist here. Scattered groves of cottonwood trees were once present. (J. A. Baumgartner 4624, courtesy of the U.S. Geological Survey.)

B. (December 4, 2002.) The city of Tempe has grown considerably, requiring bank protection along the Salt River to allow floodplain development. The Rio Salado Project, a river-restoration effort for the Salt River through Tempe, consists of a lake confined within the soil-cemented banks of the Salt River. The once wide and shallow channel is now lower into the floodplain and anchored in space, minimizing the potential for meander migration. (T. Brownold, Stake 4442.)

amount of change that has occurred in this reach (figs. 24.12 and 24.13). Many early photographs show an open gallery forest of cottonwood with low shrubs that may be coyote willow. Significantly, some of these stands of riparian vegetation appear to form a narrow band on a low floodplain beneath higher terraces, reminiscent of the condition present in arroyos. During the first third of the twentieth century, riparian vegetation was becoming reestablished within the eroded channel margin, as occurred along the Santa Cruz River at Tucson (chapter 21). Other photographs from the middle of the twentieth century (fig. 24.12A) show mostly herbaceous vegetation along the channel.

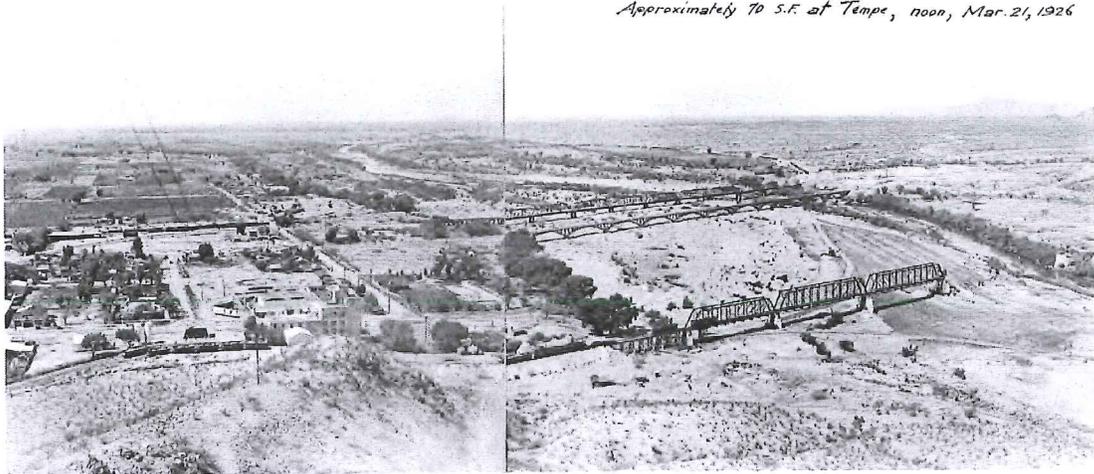
Figure 24.13 Photographs of the Salt River from Tempe Butte.

A. (March 21, 1926.) This set of photographs makes a panorama of the Salt River Valley west of Tempe Butte. The closest bridge was destroyed by a flood many years before this photograph was taken. A discontinuous row of Frémont cottonwood trees appears along low flow in the channel, which the photographer estimated to be 70 ft³/s. What appear to be more extensive stands of woody riparian vegetation appear in the background. From this distance, it is uncertain whether these stands are mesquite, cottonwood, or black willow. (Unknown photographer, courtesy of the Salt River Project, Phoenix, Arizona.)

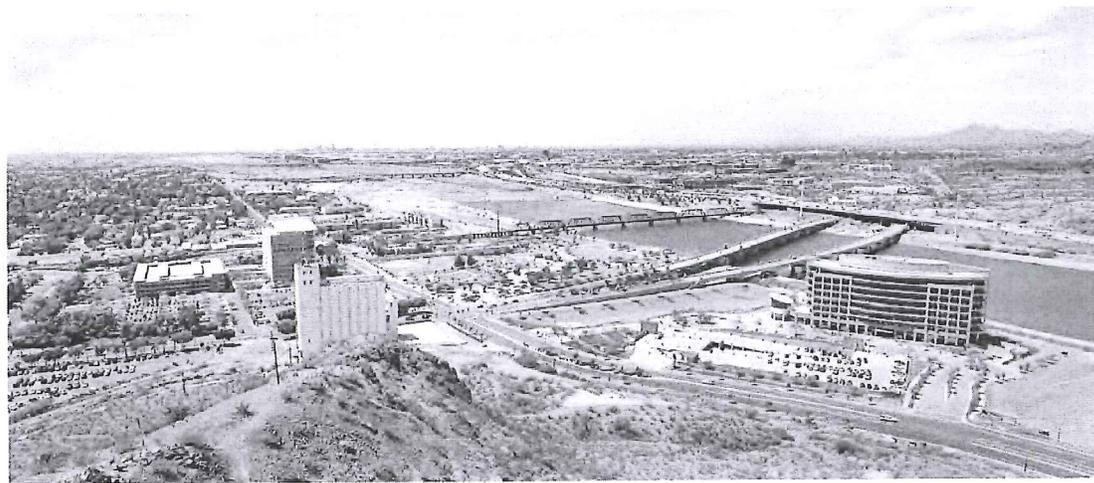
B

B. (April 7, 2004.) Most of the channel of the Salt River in this view is part of Tempe Lake, impounded by an inflatable dam and part of the Rio Salado Project. Of the three bridges visible in 1926, only one remains the same, and three new highway bridges have been built. The river is channelized through the Salt River Valley, and development occurs up to the edge of the channel in many places. (D. Oldershaw, Stake 4764.)
