# NAVIGABILITY ALONG THE NATURAL CHANNEL OF THE VERDE RIVER, AZ

Detailed analysis from Sullivan Lake to the USGS gage near Clarkdale.  
and  
General analysis from Clarkdale gage to mouth.

An assessment based on history, Federal GLO surveys,  
hydrology, hydraulics and morphology

Hjalmar W. Hjalmarson, PE

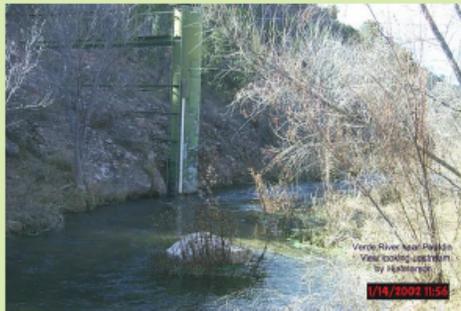
Figure 16C. View from top of reach looking downstream during low flow, Verde River near Paulden.

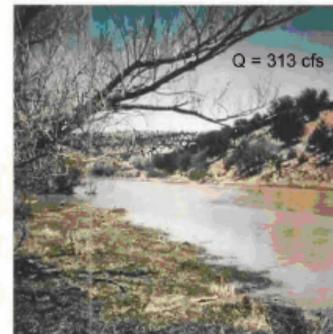
Figure 16D. View from top of reach looking downstream at time of verification measurement, April 16, 1965, Verde River near Paulden.

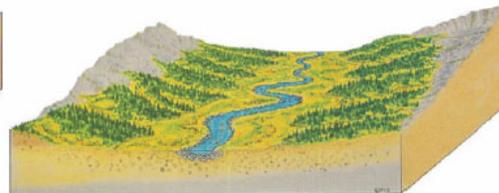
**Type B (19% of UVR) moderately entrenched channel (W/d ratio >12)**

Characteristics typical of C-, B-, F-, and E-type stream channels found in the UVR.

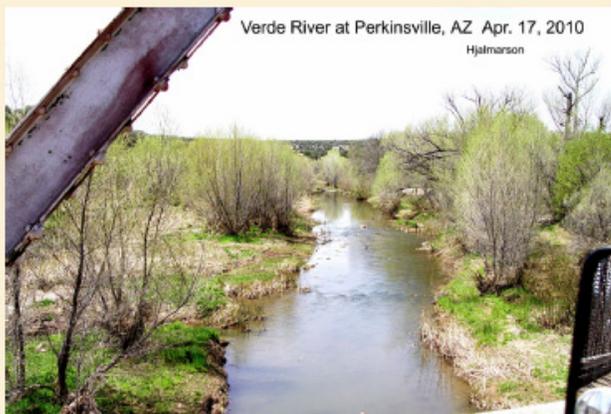
Verde River at Perkinsville, AZ Apr. 17, 2010  
Hjalmarson

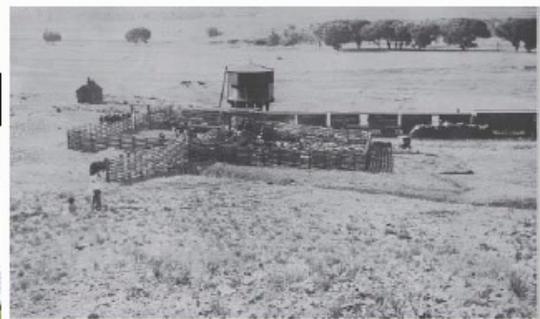
Figure 2.7—Photo looking south across the Perkinsville valley depicting the condition of the UVIH circa 1920s. The river runs through a valley devoid of woody plants and irrigated bottomland (ditches in foreground) where horses are seen grazing. Streamside vegetation was largely herbaceous and lacking woody plants. The floodplain morphology is a gentle "C" type channel with single backwash for flood waters to spread. A small grove of cottonwoods nestled along an older terrace. (Photo courtesy of the Sharbel Hall Museum, Prescott, Arizona.)

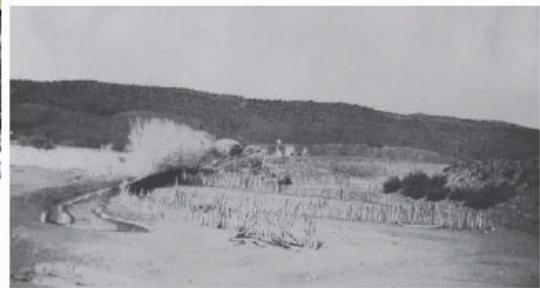
Figure 2.8—This photo was taken from the Perkinsville Road looking east and shows the horse lead on the south side of the river. A stand of young cottonwoods, likely less than 10 years old, can be seen growing along the irrigation ditch. These same cottonwoods are seen in figs. 2.30 to 2.42. (Photo courtesy of the Sharbel Hall Museum, Prescott, Arizona.)

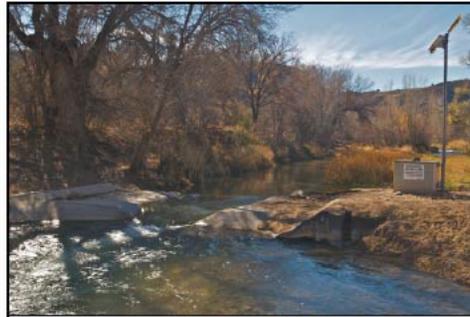
Figure 10. Campbell Ranch low-Flow Gage. Photo credit: Gary Beverly

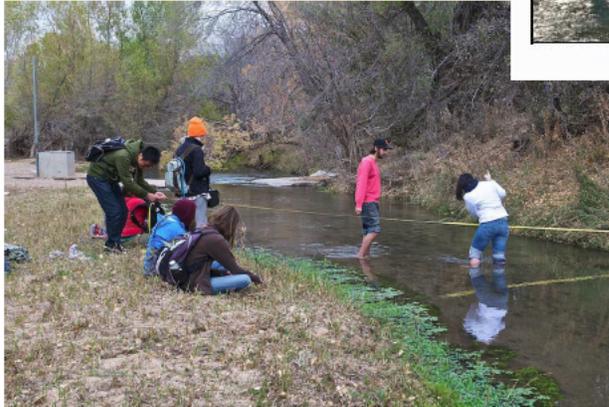
Verde River at SRP lo flow site  
Cross section above gage

Stage ft	Width ft	Area sq ft	Velocity ft/sec	Discharge cfs
0.0	0	0.0	0.0	0.0
1.4	9	10.4	1.06	11.0
1.5	16	11.0	1.05	11.5
2.0	23	22.0	1.32	29.0
2.5	33	36.0	1.39	50.0
3.0	45	60.0	1.50	90.0

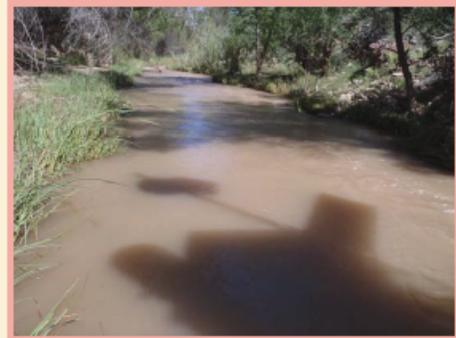
Verde River near Paulden 09503700  
Main Channel at cableway  
from USGS meas. on 1/11/2005

Depth ft	Width ft	Velocity ft/s	Discharge cfs
0.0	0.0	0.00000	0.000
2.0	20.0	1.49352	37.338
3.0	24.5	1.96917	94.520
3.7	28.0	2.22281	146.705

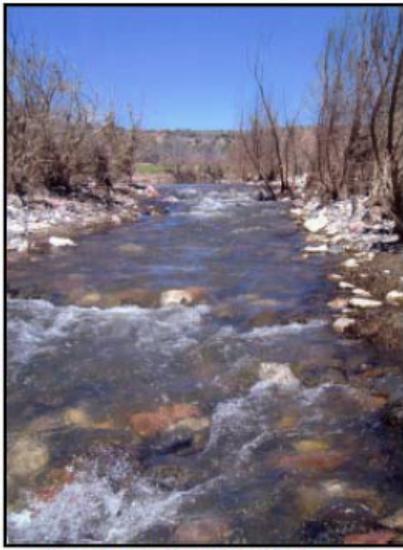
Figure 13. Verde River at Bear Siding in winter.  
Photo credit: Tom Slaback

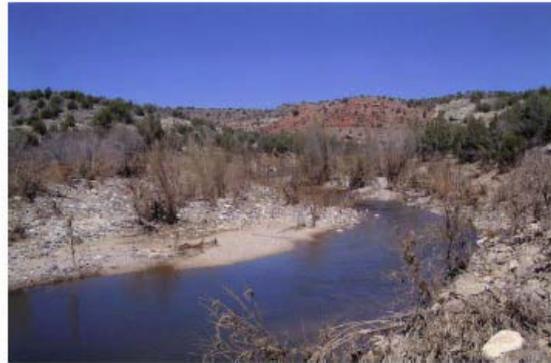
Figure 3. The upper Verde River near Bear Siding  
Photo credit: Tom Slaback

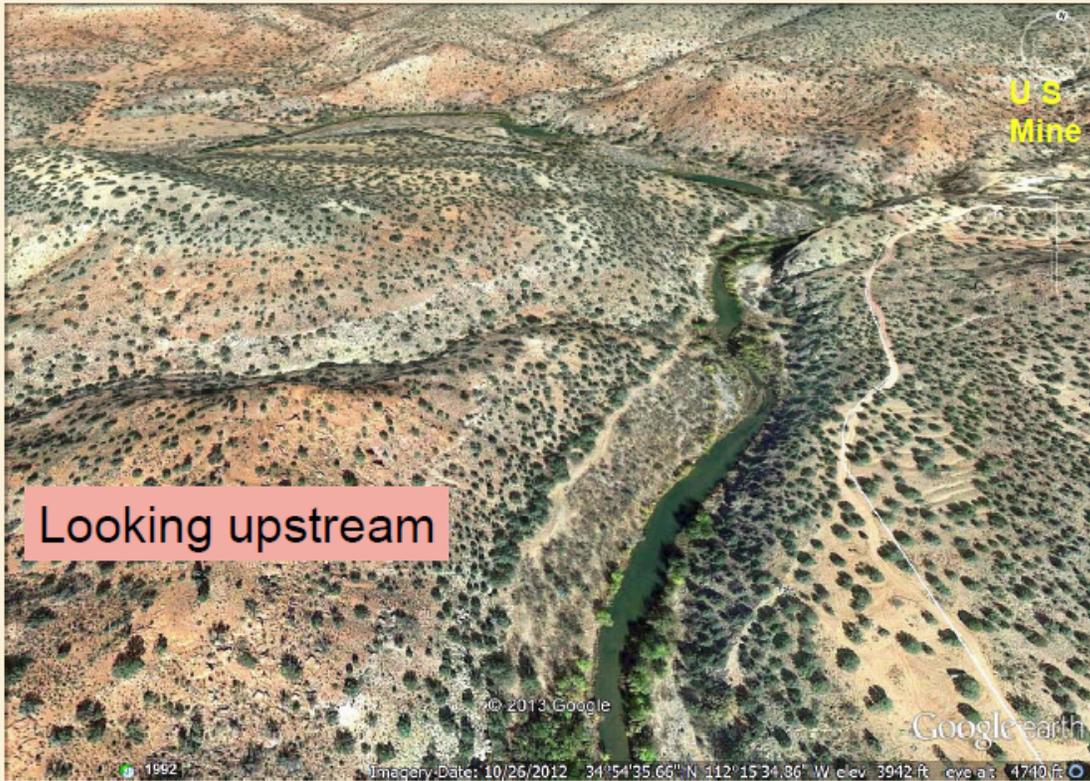
Verde River short distance upstream of Perkinsville. View looking upstream. Q = about 22 cfs.

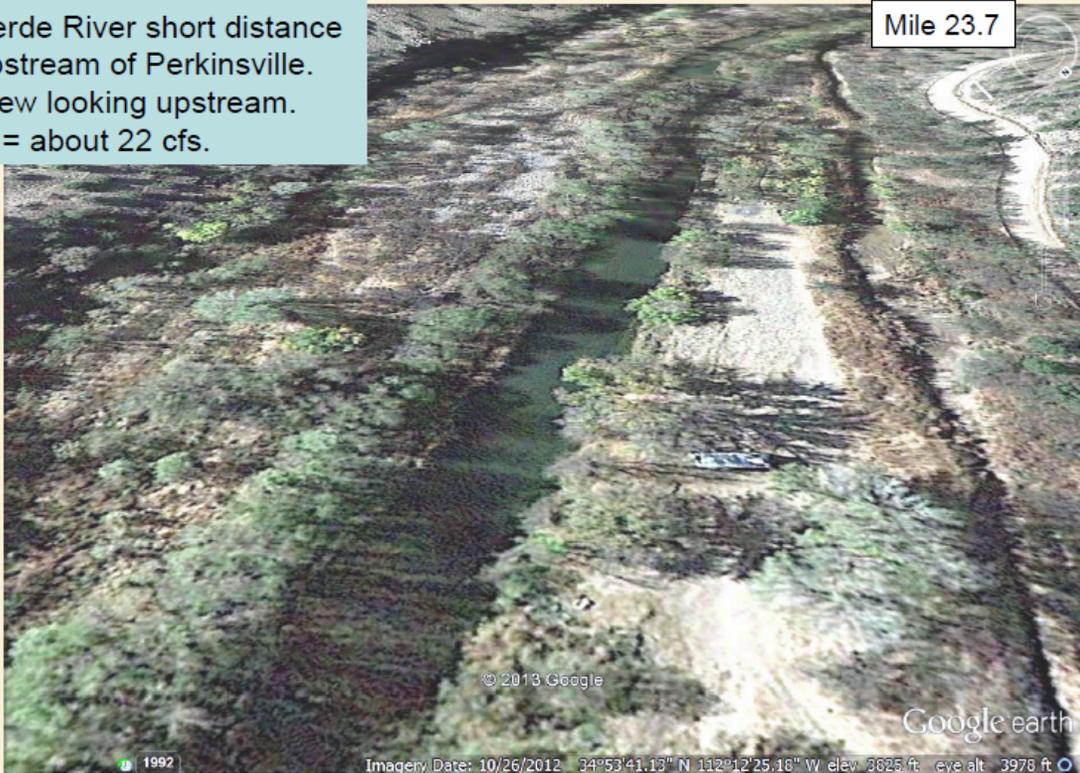
Perkinsville

Stage	all	Width	Area	Velocity	Discharge
0.0		0	0.0	0.00000	0
1.6		20	21.0	0.85714	18
2.0		25	30.0	1.20000	36
2.8		36	53.4	1.49813	80
3.0		39	60.0	1.50000	90

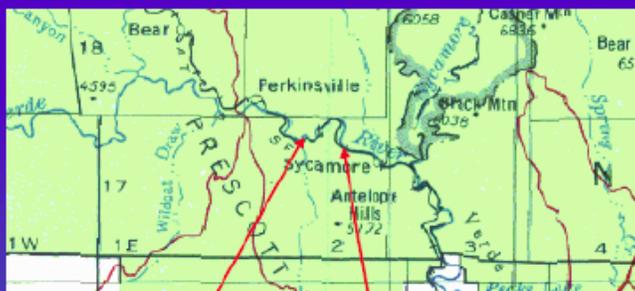
Upper Verdes River Bissetow Discharge Measurements

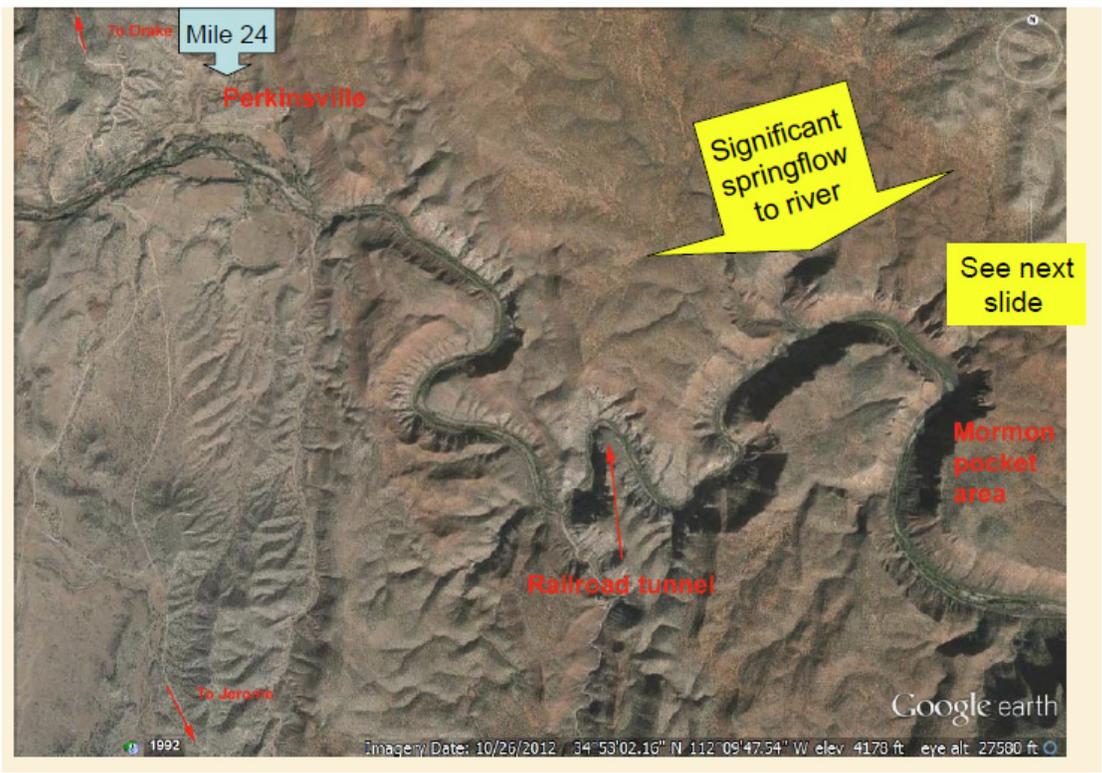
Verde River between Clarkdale gage and Sycamore Creek. View looking upstream. Q = 67 cfs.

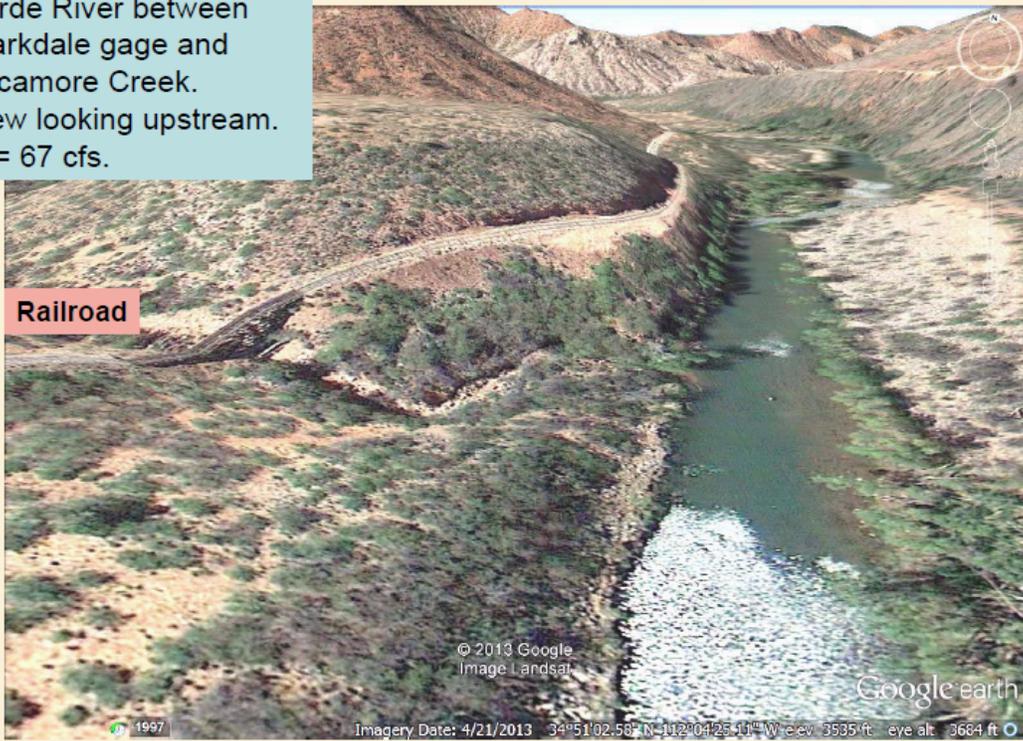
Verde River at USGS gage 09504000. View looking upstream at channel approaching gage. Q = 62 cfs.

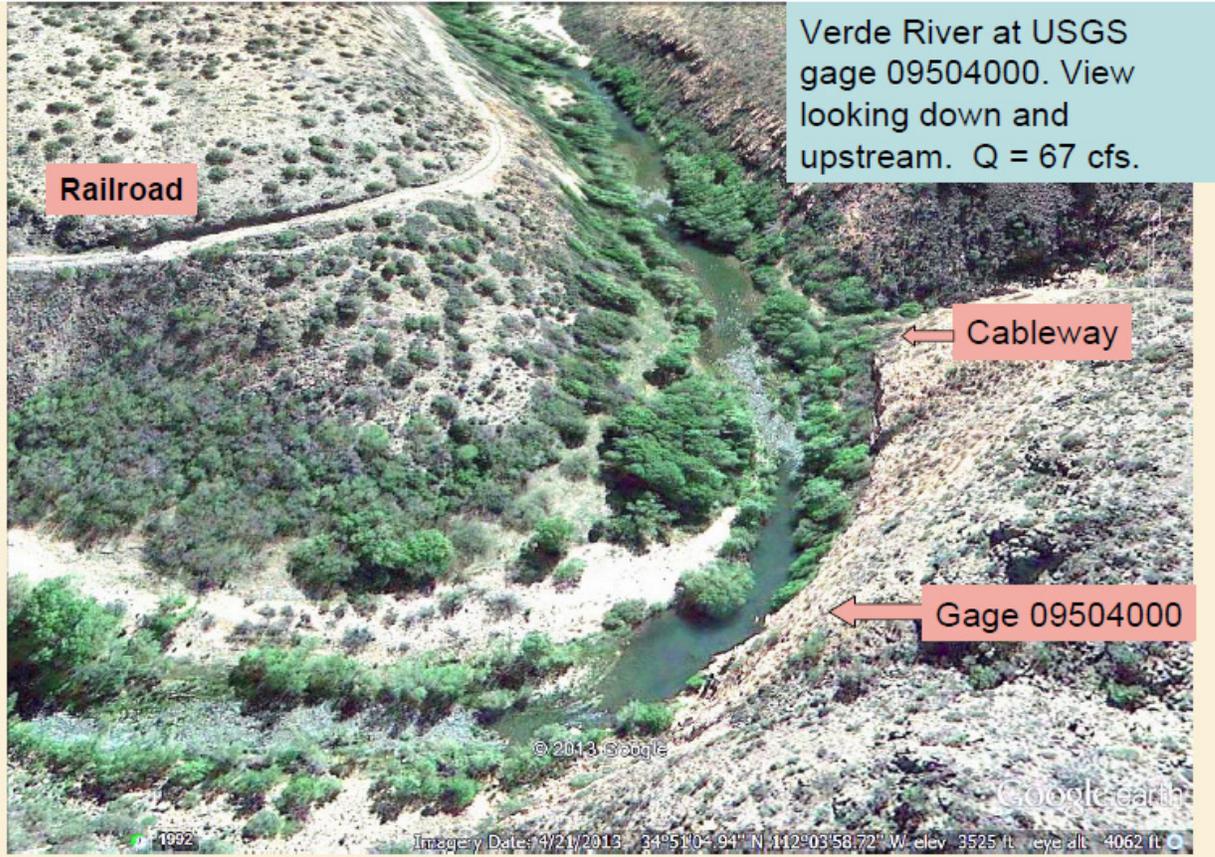
Verde River near Clarkdale, Az 09504000

USGS current meter measurement at cableway

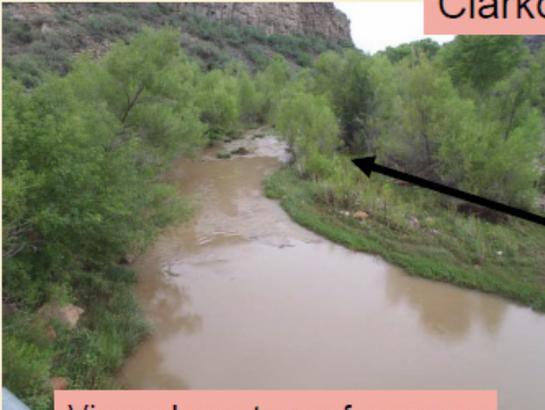
Views downstream from gage

The riffle to the left “drowns out” as discharge increases as shown in the photo below. It’s common for riffles and “section controls”, where critical velocities exist, to become channel controls with sub-critical flow velocities as stage increases. Thus, I would expect fewer riffles under natural when the base flow was large.

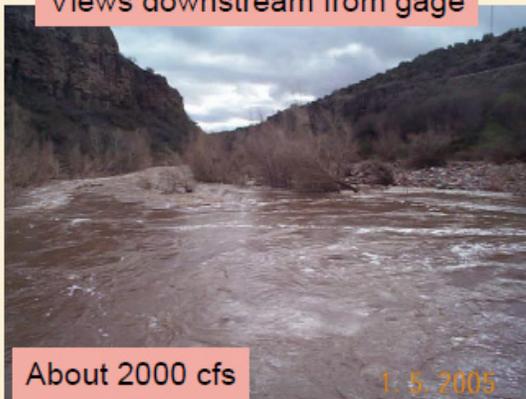
About 2000 cfs

1.5.2005

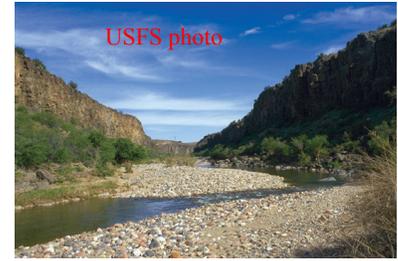
The transport of sediment debris by rivers like the Verde River is common knowledge. The forces (eg.-shear forces) involved in shaping and maintaining the channel are related to both the amount and duration of water flow. As flow (energy) in this scene increases, the silt and sand can become suspended in the flow and the gravel, cobbles and small boulders can be moved by pushing, rolling and skipping. The rate of sediment transport is much less for base flow than flood flow but the duration of base flow is considerably longer.

Photo above of cobbles near Sycamore Canyon. (Photo by James Cowlin USFS).

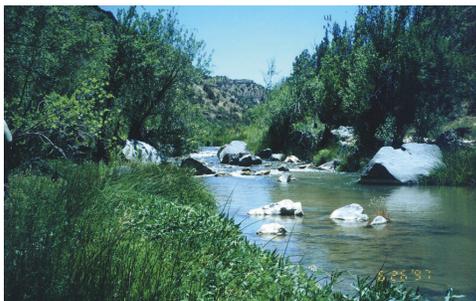
An example of slope processes where debris is shed toward and into the river channel. Large debris (boulders) will remain as obstructions to navigation until moving downstream by continuous and high energy river flow.

Large debris (boulders) from side slopes. Obviously only very large, or high, (kinetic) energy flow will move such large obstructions. Also, energy is lost (with a corresponding decrease of velocity and increase in depth) as streamflow encounters this rough channel material.

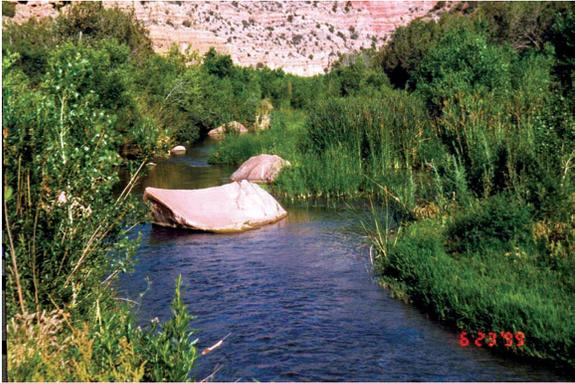
The “Otter Rock” in the Upper Verde River channel in the Horseshoe Allotment in 1998, five years after the large 1993 flood. (Photos by Alvin L. Medina, USFS).

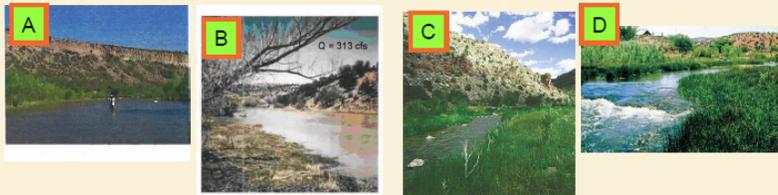
There are alternating pools and riffles along the Verde River and many of the riffles are located at the mouths of tributaries that dump flood debris into the Verde River. Most of the channel bed is gravel and cobbles with sand and boulders. These conditions are typical of nearly all perennial gravel bed streams and streams where the bed material is larger than coarse sand.

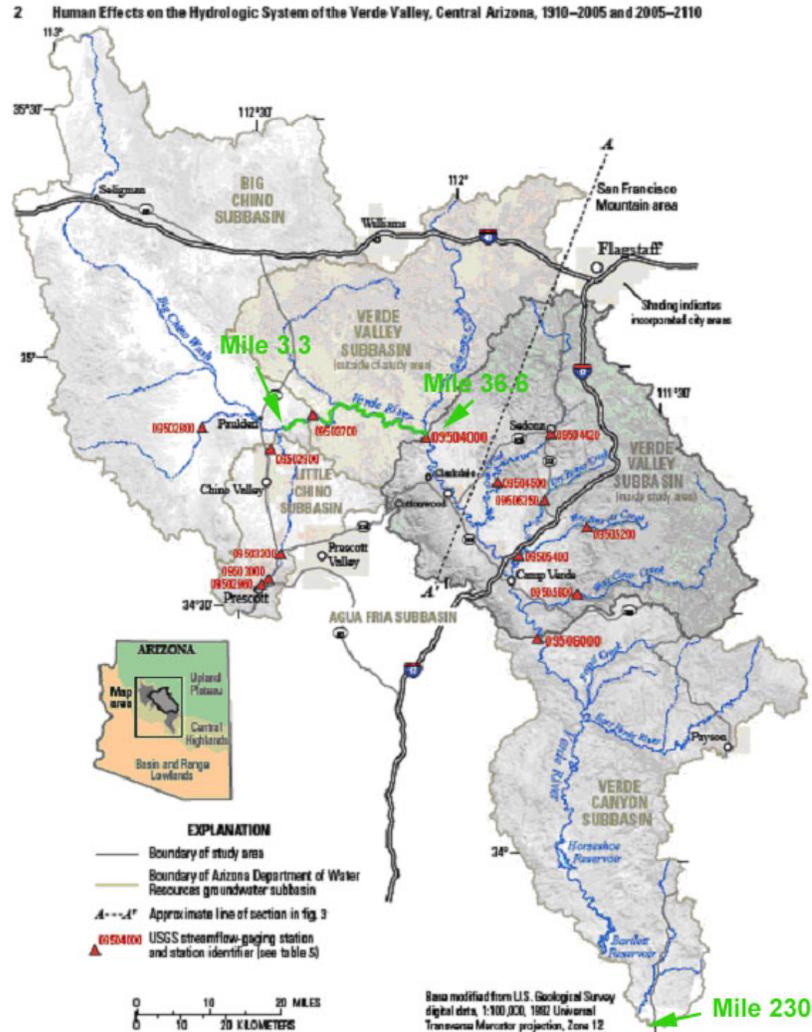
The two Federal methods show that in its ordinary and natural condition, the Upper Verde River along the study reach from the Stewart Ranch area (mile 3.3) to the USGS stream gage near Clarkdale (mile 36.6) was navigable (Following Figure).
